# INSPECTION REPORT

For the Property at:  
**26 MAIN STREET**  
TORONTO, ON M4E 2V4

Prepared for: THE CURRENT HOME OWNER FOR PRE-LIST INSPECTION ONLY  
Inspection Date: Saturday, July 18, 2026  
Prepared by: Mario Nigro

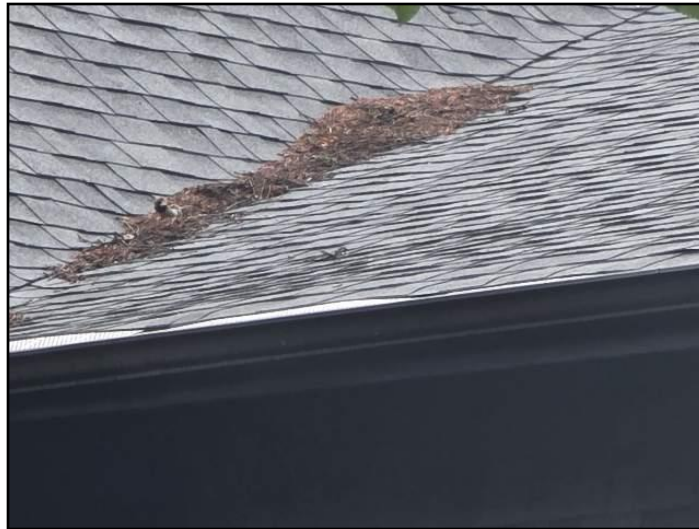
**1. Condition:** • Annual roof tune-ups are recommended to find and repair damage to roofing materials, flashings and caulking. Roof tune-ups reduce the risk of leaks and resulting water damage and help extend the service life of the roof. Maintain all Roof surfaces

2. Tune-up

**Task:** Further evaluation by qualified Roofing contractor -Every 10 years / Tune-up, clear excess debris and Repair as needed

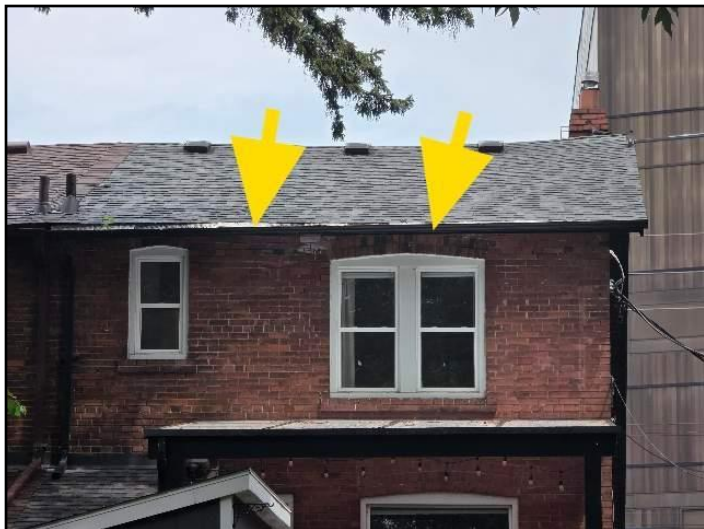
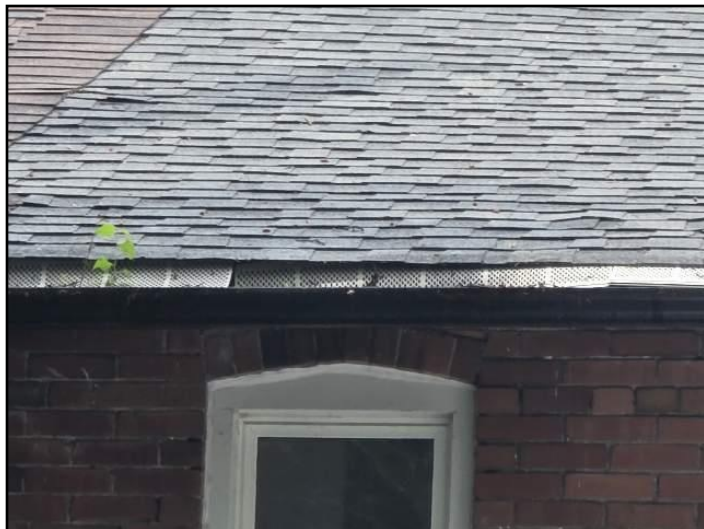
**3. Condition:** • Loose

**Location:** Rear

8. Loose

9. Loose

**Task:** Improve -Secure as needed

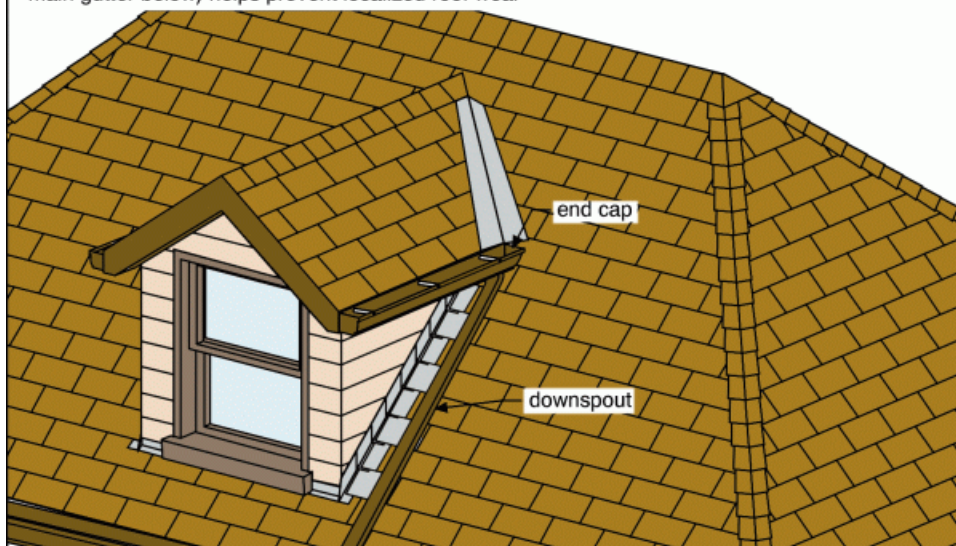
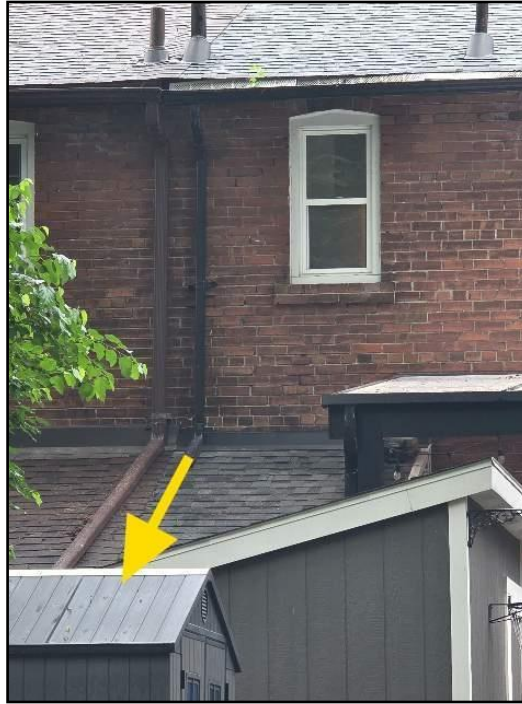
4. Condition: • Discharge onto roofs

Implication(s): Chance of water damage to structure, finishes and contents

Location: Rear -low roof above addition (1 -downspout)

10. Discharge onto roofs

Task: Extend downspout pipe to discharge water directly into lower gutter

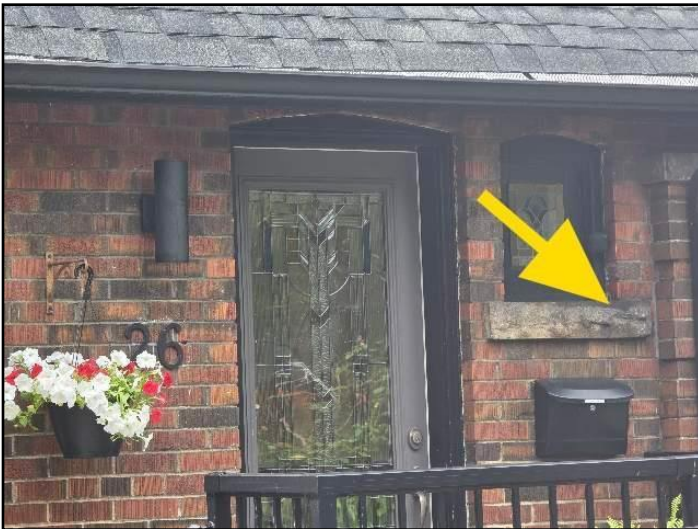
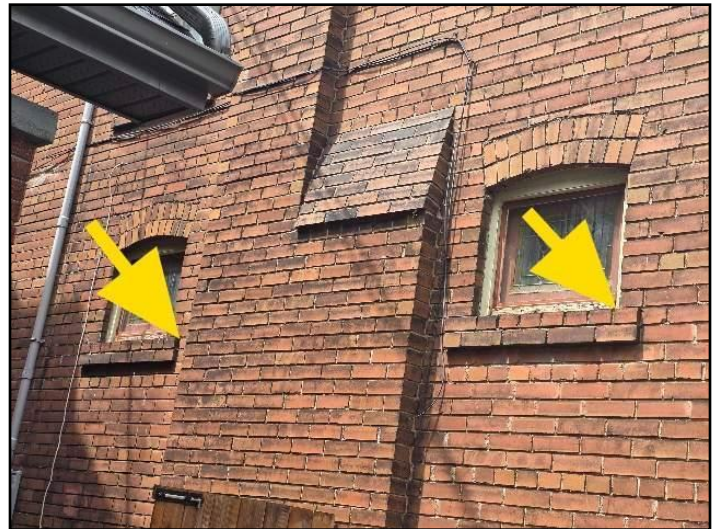
**5. Condition:** • Paint and Caulking - deteriorated / missing

**Location:** Front (1 -window) & Left side (2 -window)

11. Paint and Caulking - deteriorated / miss

12. Paint and Caulking - deteriorated / miss

**Task:** Repaint wood surfaces & Replace Caulking

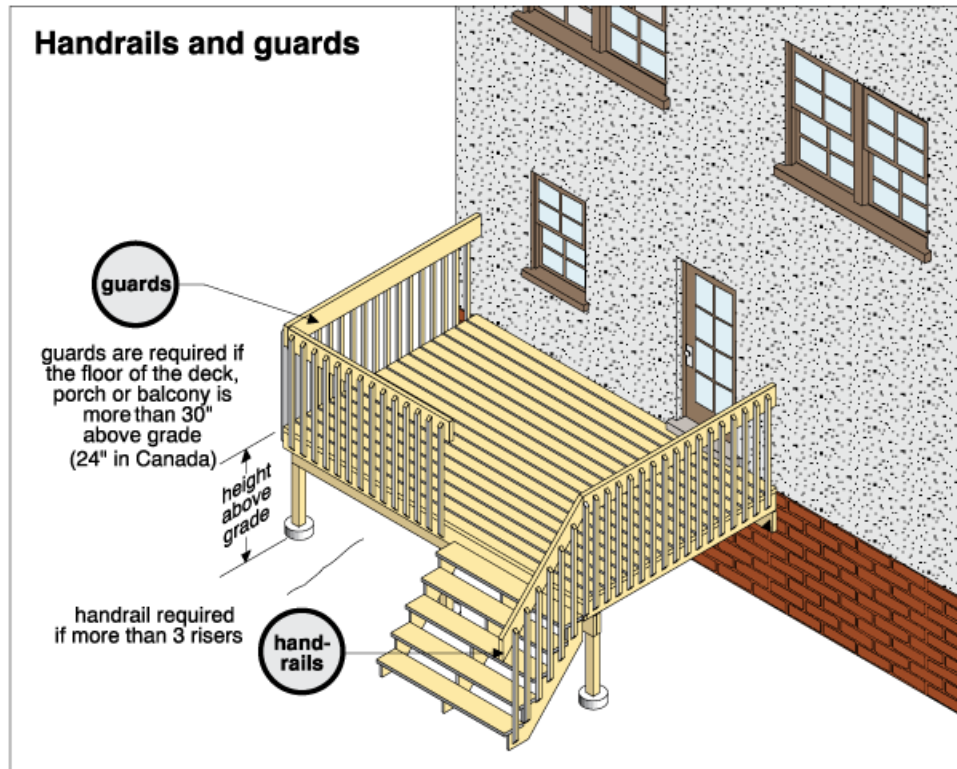
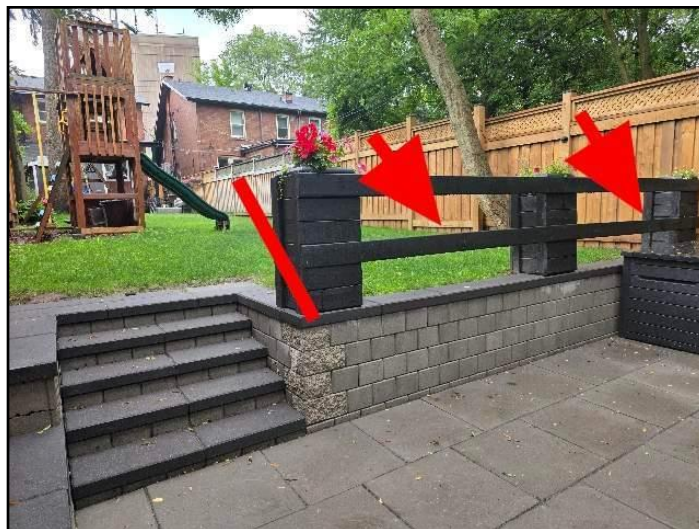
**6. Condition:** • [Missing](#)

Missing Railing at steps.

Guard was Climbable and Large gaps can allow for falls to occur.

**Implication(s):** Fall hazard

**Location:** Backyard -near Patio closer to rear property line

13. Missing

**Task:** Provide Railing (at steps) & Improve Guard (horizon spindle or glass)

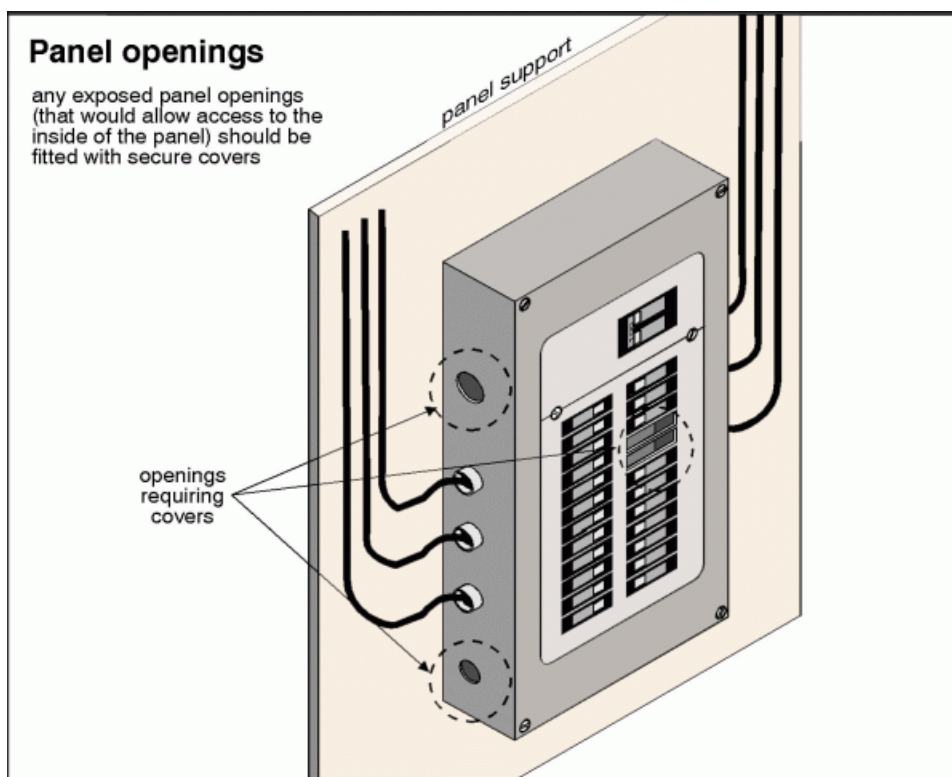
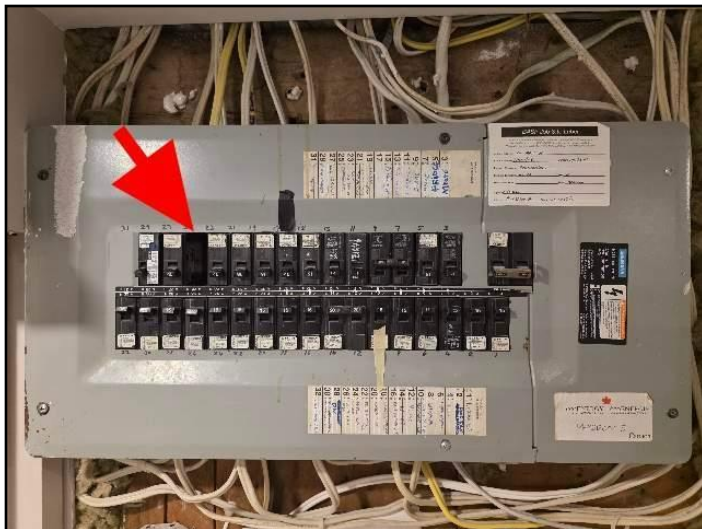
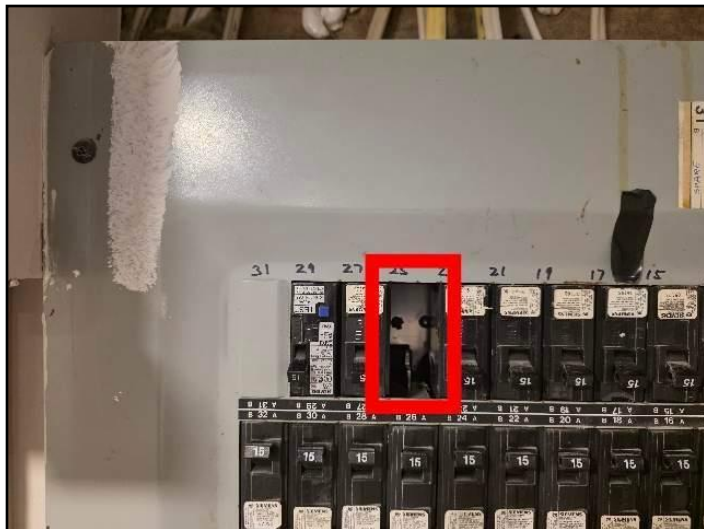
**8. Condition:** • [Unprotected openings](#)

**Implication(s):** Electric shock

**Location:** Basement -main Electrical panel cover (1 -opening)

19. Unprotected openings

20. Unprotected openings

**Task:** Close down

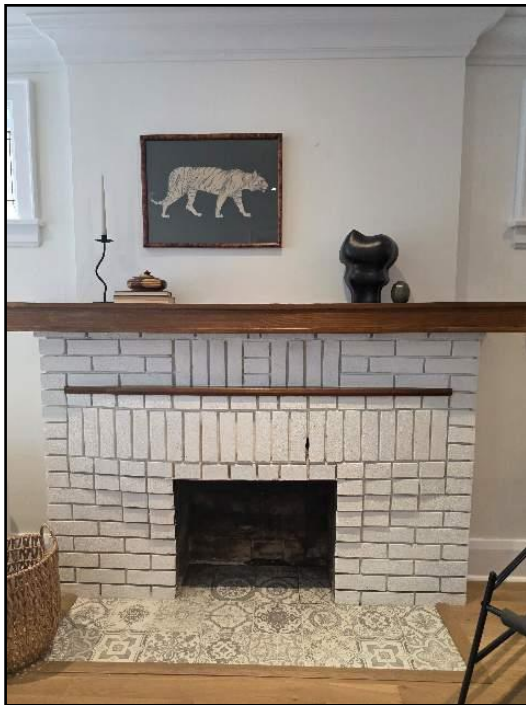
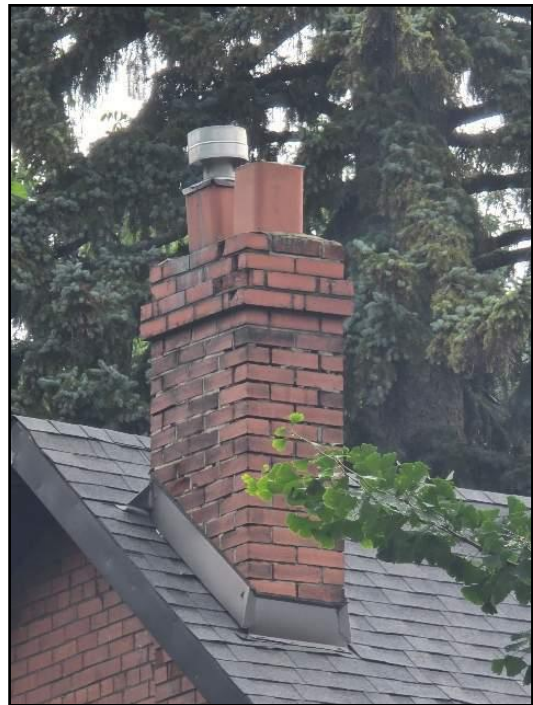
**12. Condition:** • Inspect chimney, and sweep, if needed before using

**Implication(s):** Fire hazard

**Location:** 1st floor -Wood burning fireplace and associated Chimney flue

29. Inspect chimney, and sweep, if needed be

30. Inspect chimney, and sweep, if needed be

**Task:** Further evaluate by qualified Contractor & WETT certify

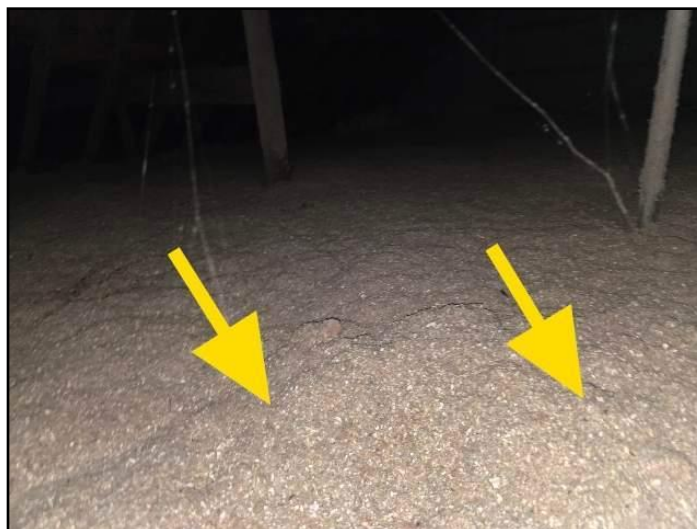
14. Condition: • [Amount less than current standards](#)

33. Amount less than current standards

Task: Increase Insulation value to current standards(R 60)

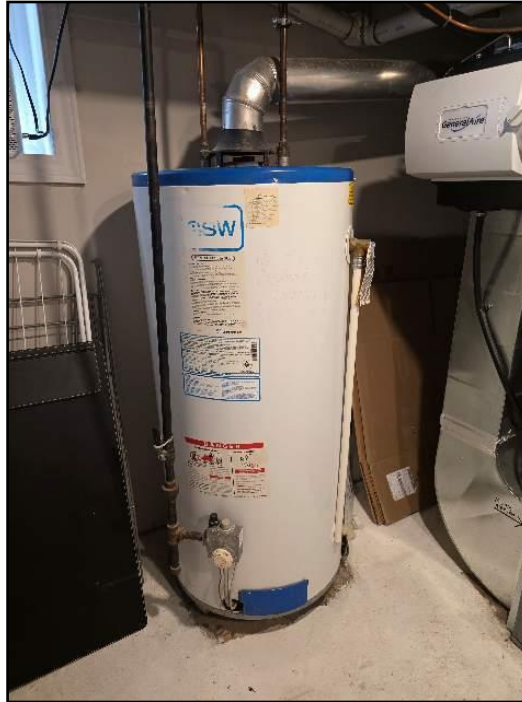
Past expected life.

**15. Condition:** • [High failure probability](#)

39. High failure probability

**Task:** Replace

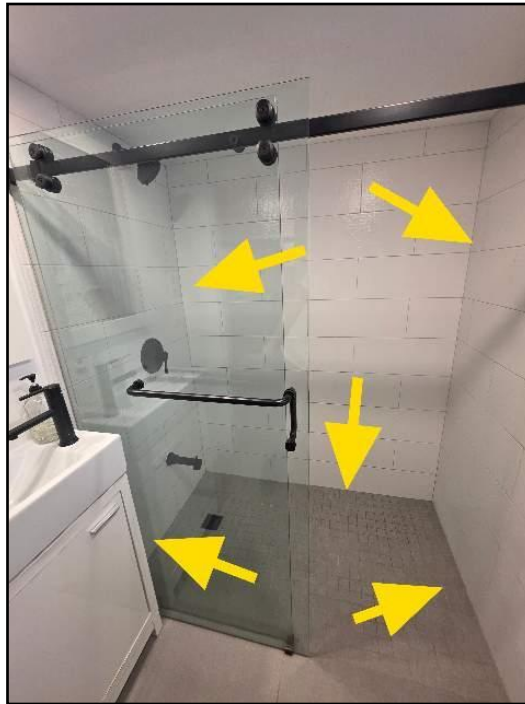
**16. Condition:** • [Caulking loose, missing or deteriorated](#)

Missing Silicone.

**Implication(s):** Chance of water damage to structure, finishes and contents

40. Caulking loose, missing or deteriorated

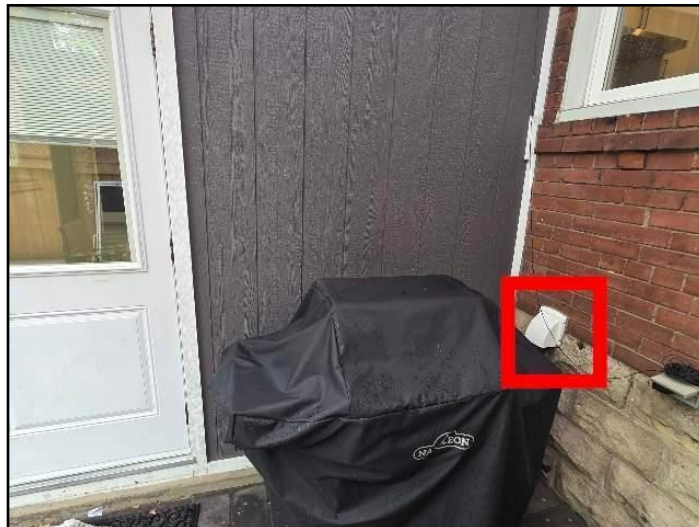
49.

**17. Condition:** • Dryer exhaust (potential for excess lint / fire hazard).

**Task:** Inspect every 6 months / Clean as needed

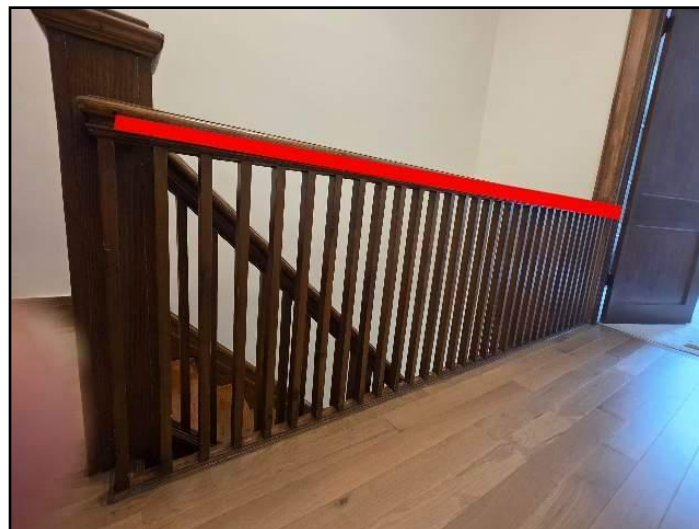
**19. Condition:** • [Too low](#)

**Implication(s):** Fall hazard

50. Too low

**Task:** Improve height to current standards(not required but strongly recommended for safety)

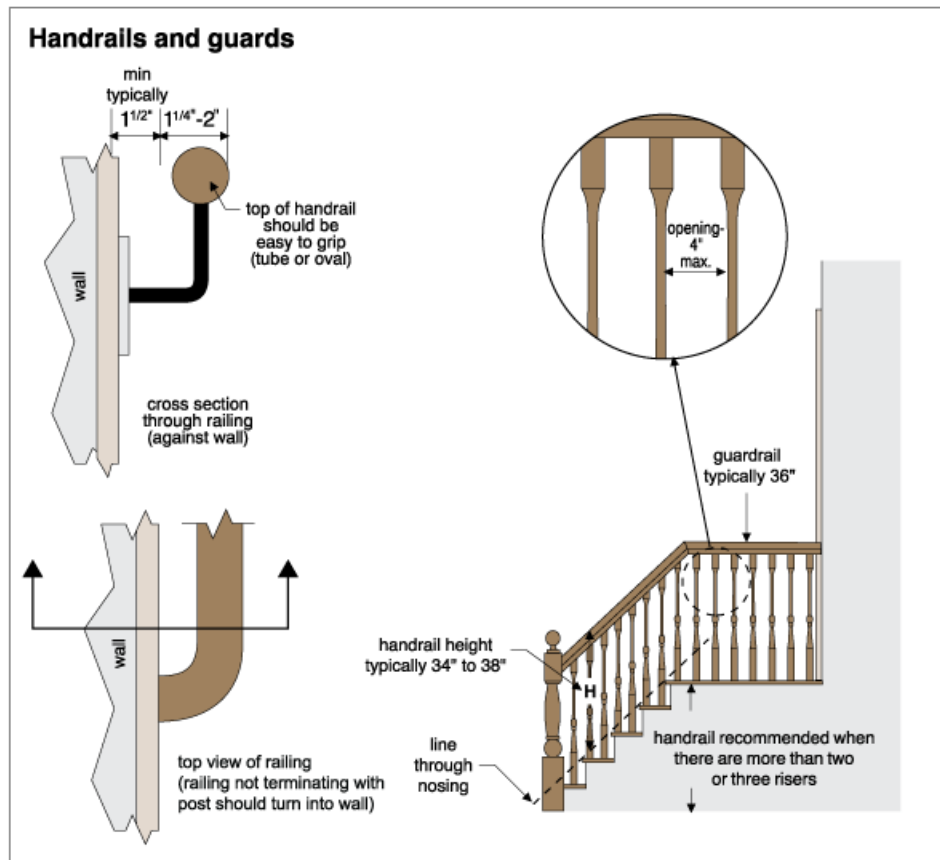
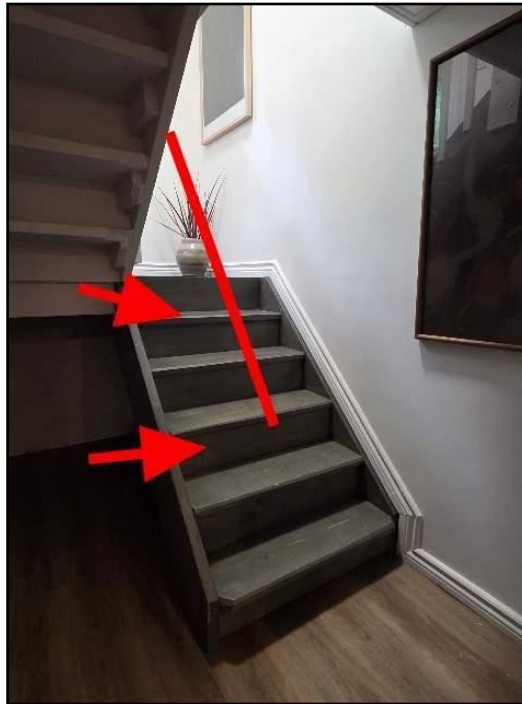
20. Condition: • [Missing](#)

Implication(s): Fall hazard

51. Missing

**Task:** Provide Railing (and proper guard)

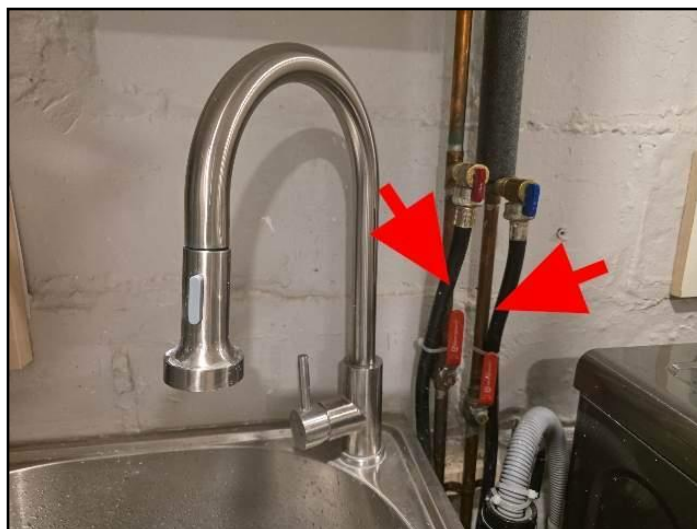
**21. Condition:** • Old/Low quality hoses

**Implication(s):** Chance of water damage to structure, finishes and contents

52. Old/Low quality hoses

**Task:** Replace with Braided flex metal

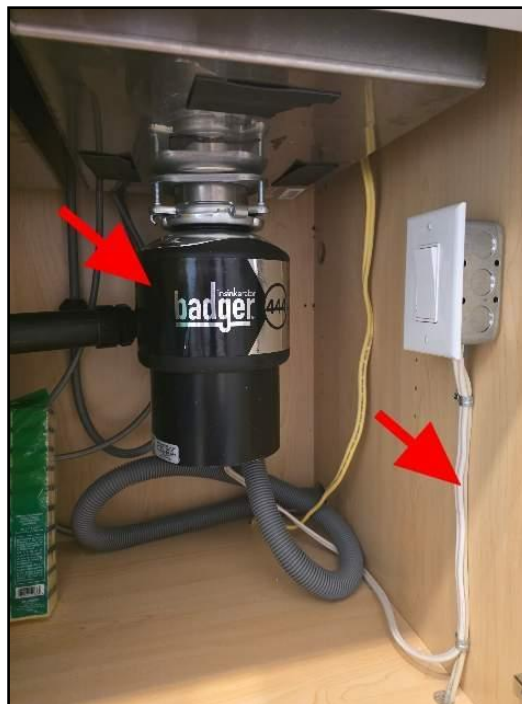
53.

**23. Condition:** • Garborator unit noted (not allowed by Municipality).

**Task:** Remove unit and associated wiring
